Photo Report of Koteles Garage

Site Inspection Date: 06/10/2020

Inspector: Nathan Marcus, E.I.T.

Prepared for: Levandosky v. Koteles Dispute

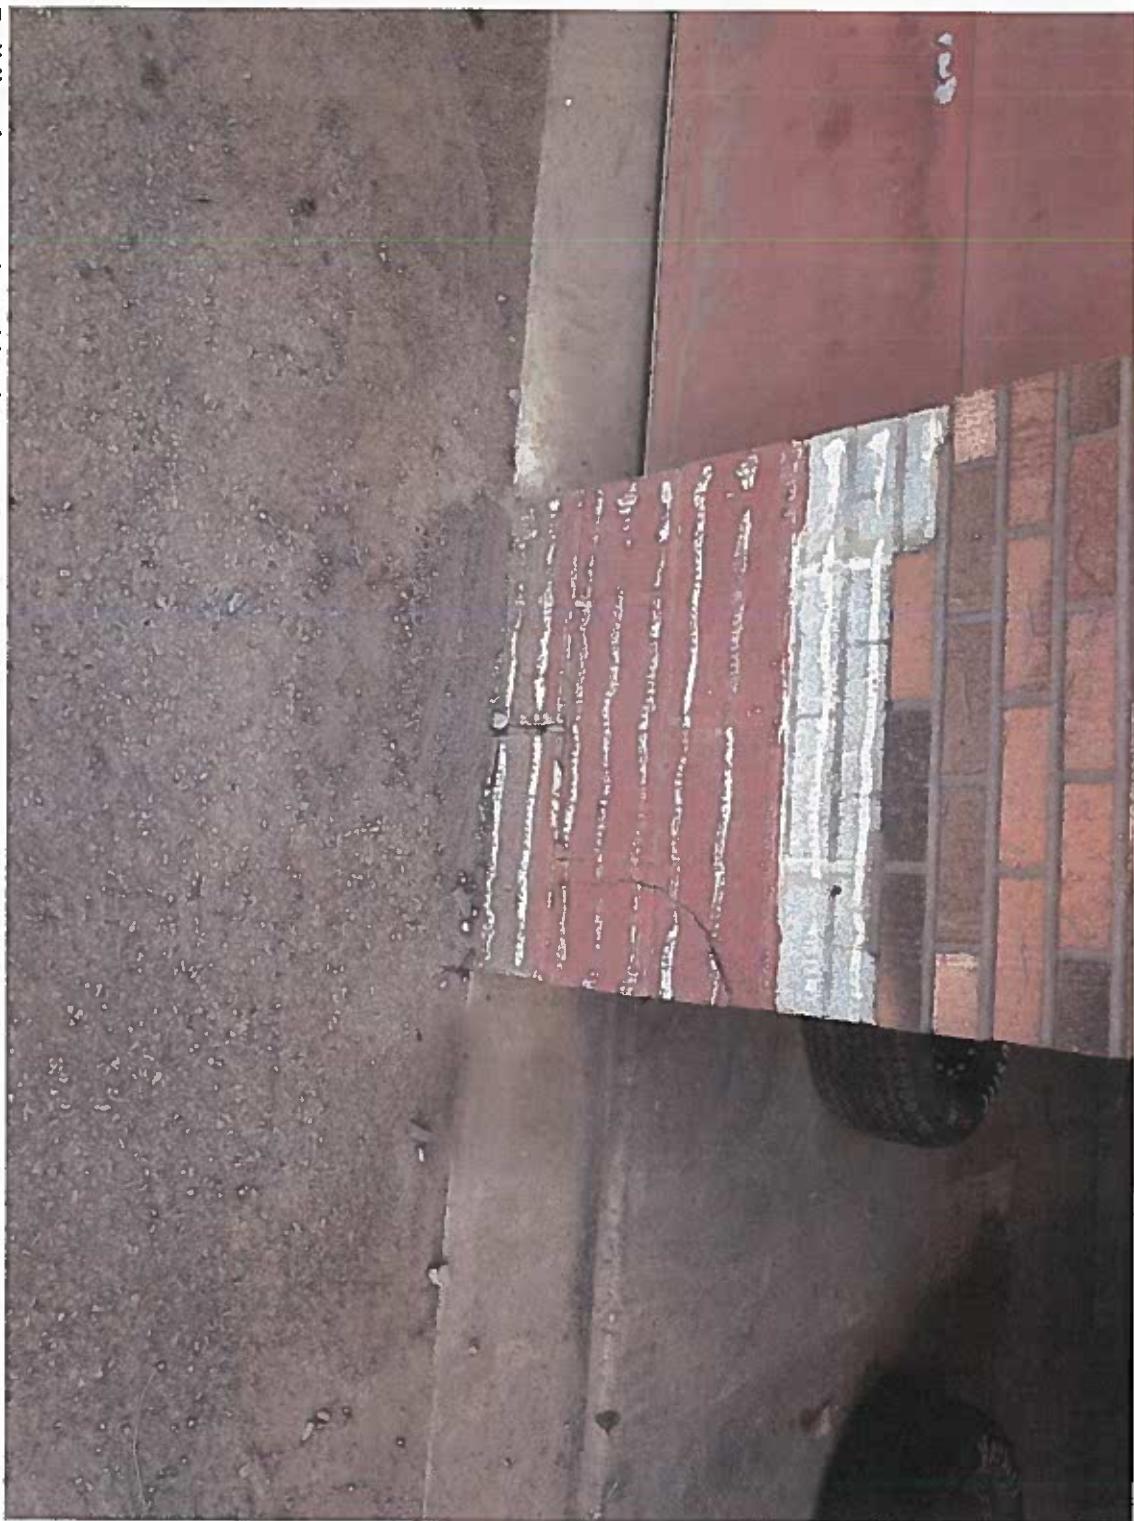
Building damage and cracking between front garage bays.

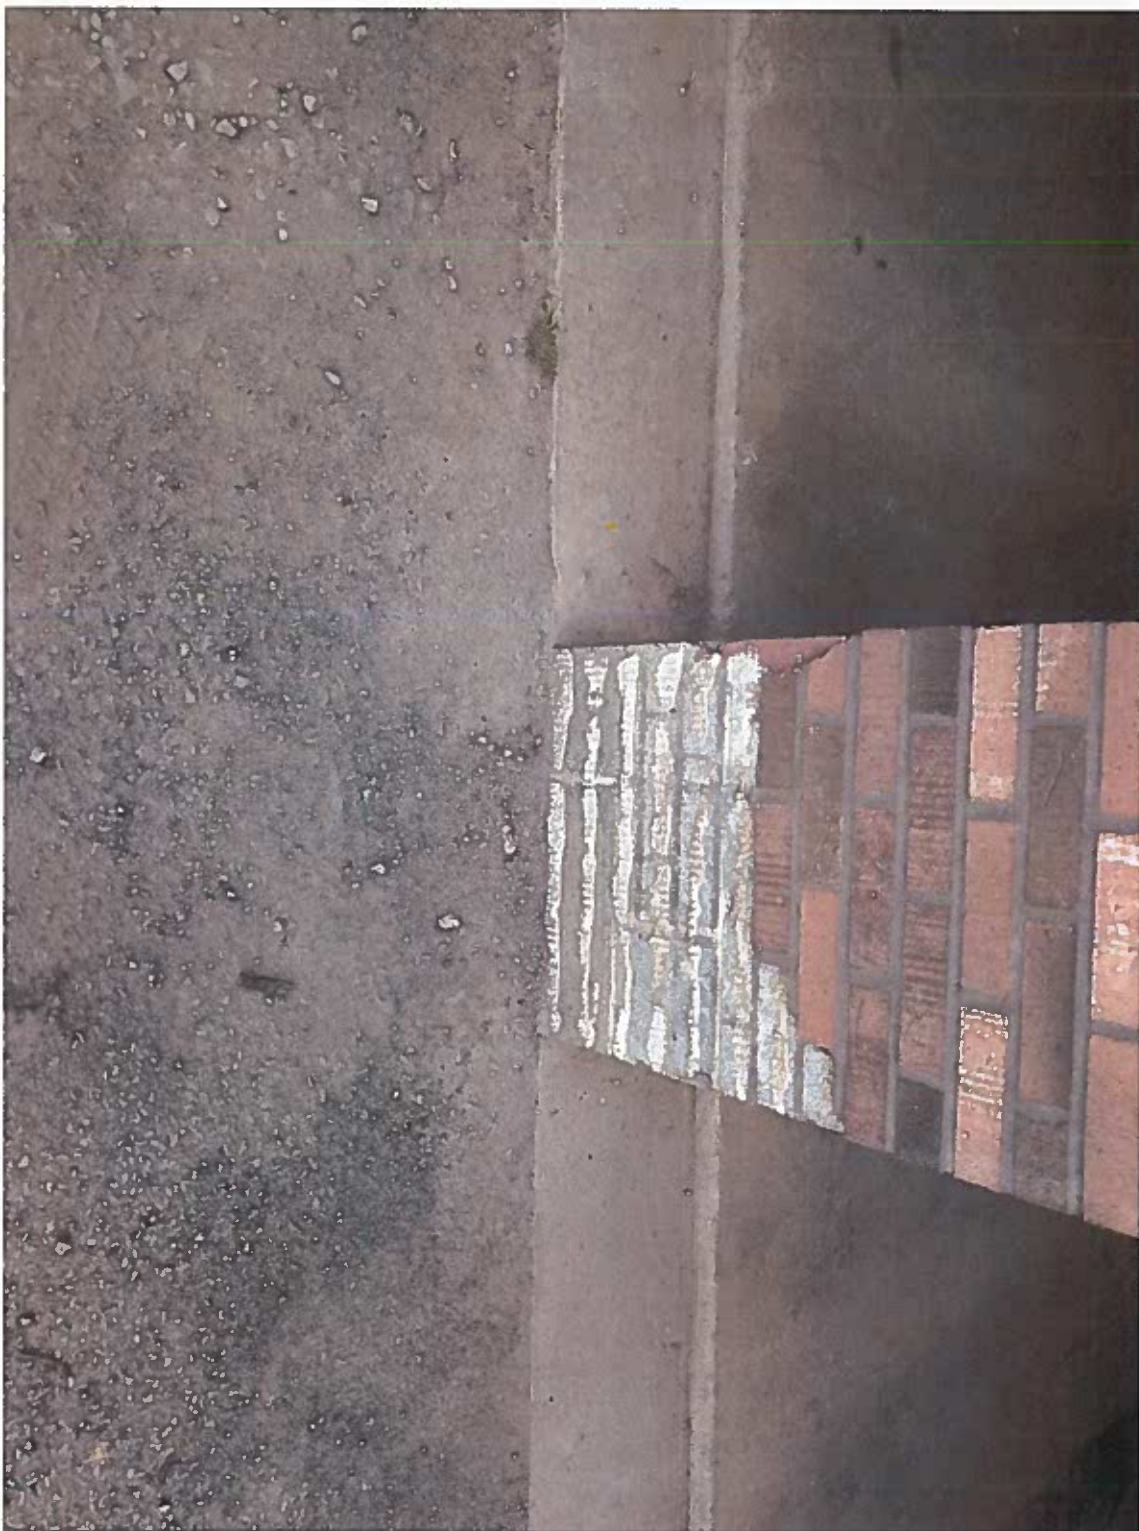
Building damage and cracking between front garage bays.

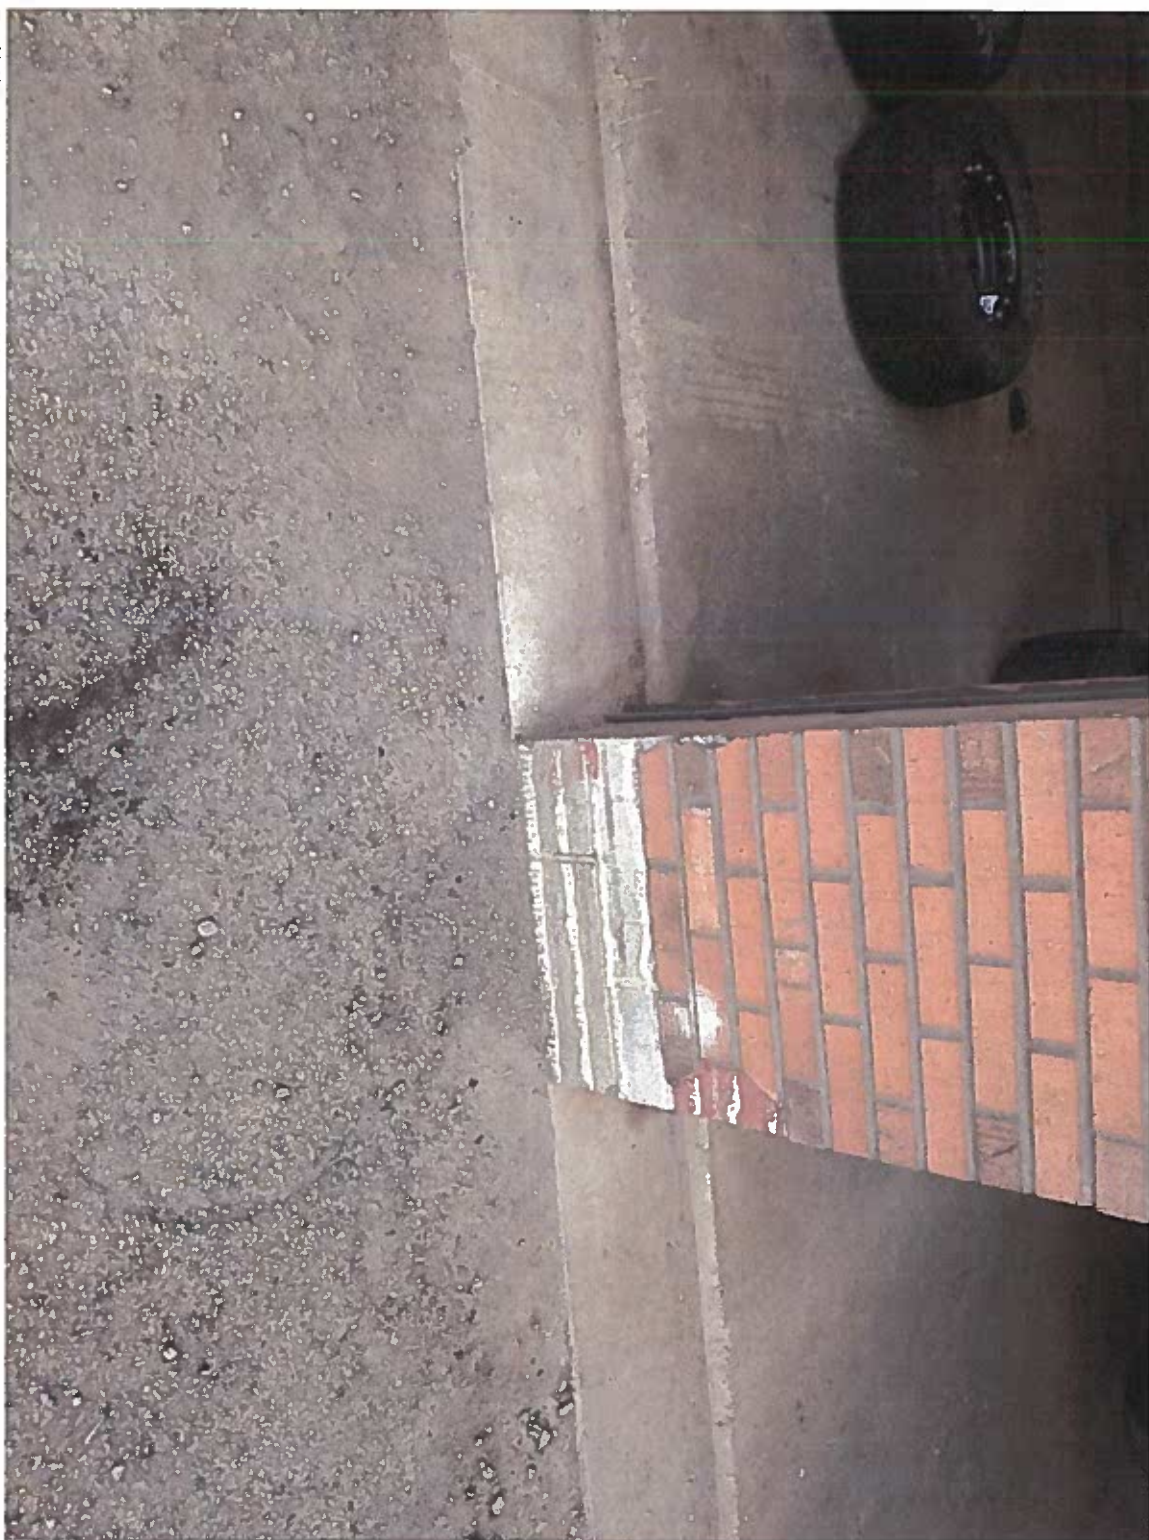
Building damage and cracking between front garage bays.

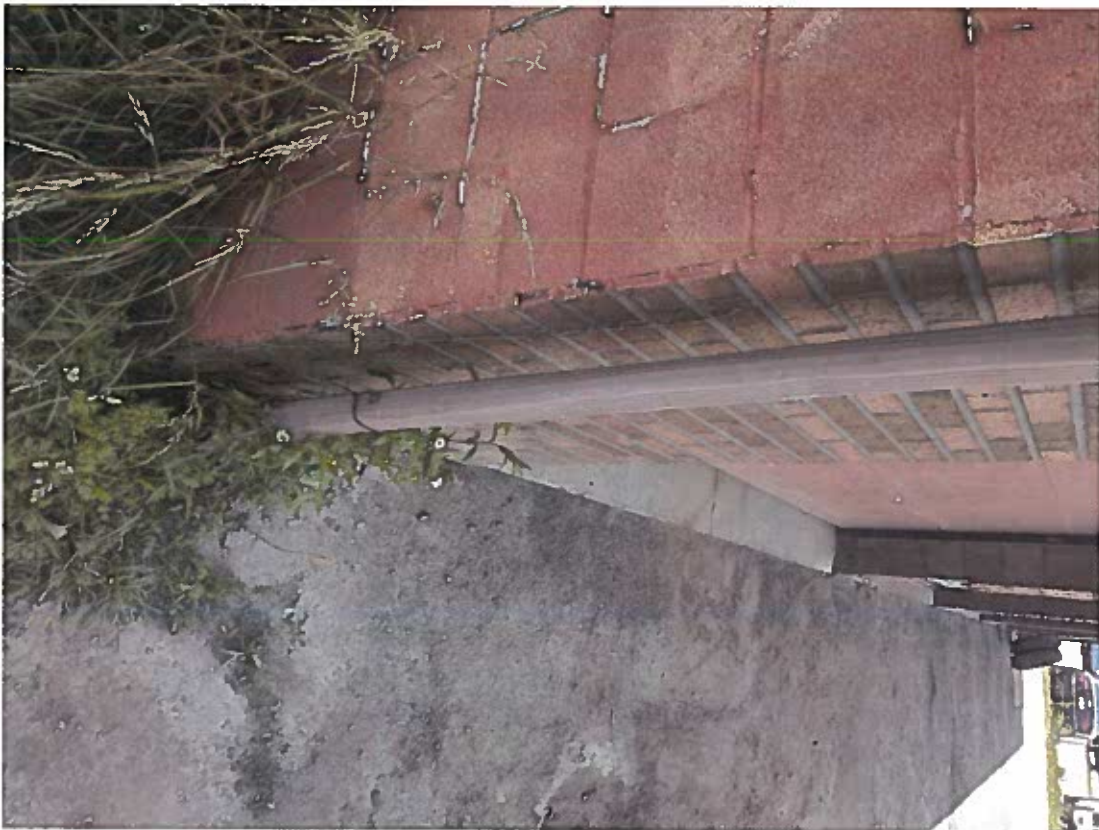
Roof downspout is unsecured from the building. There is wall damage and pavement cracking in front of garage doors.

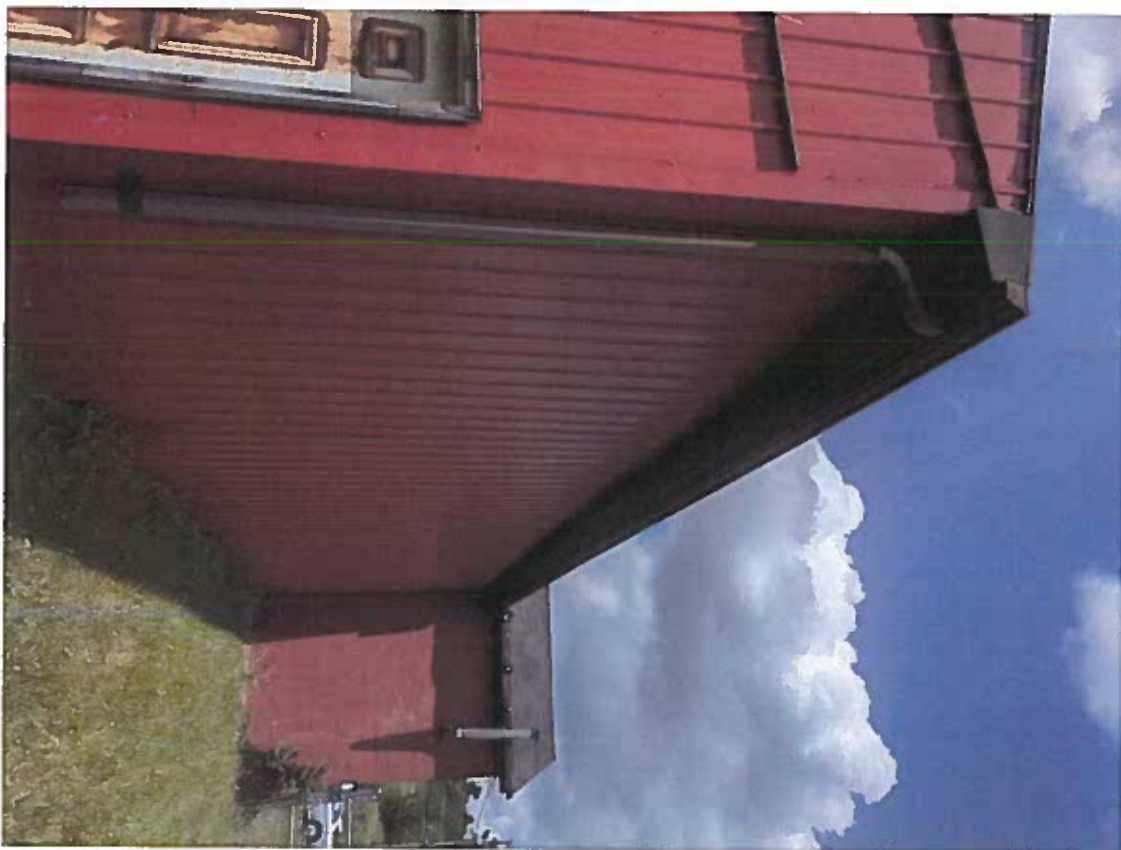
Properly secured downspout on rear of building. However, note the uncut grass and weeds near building.

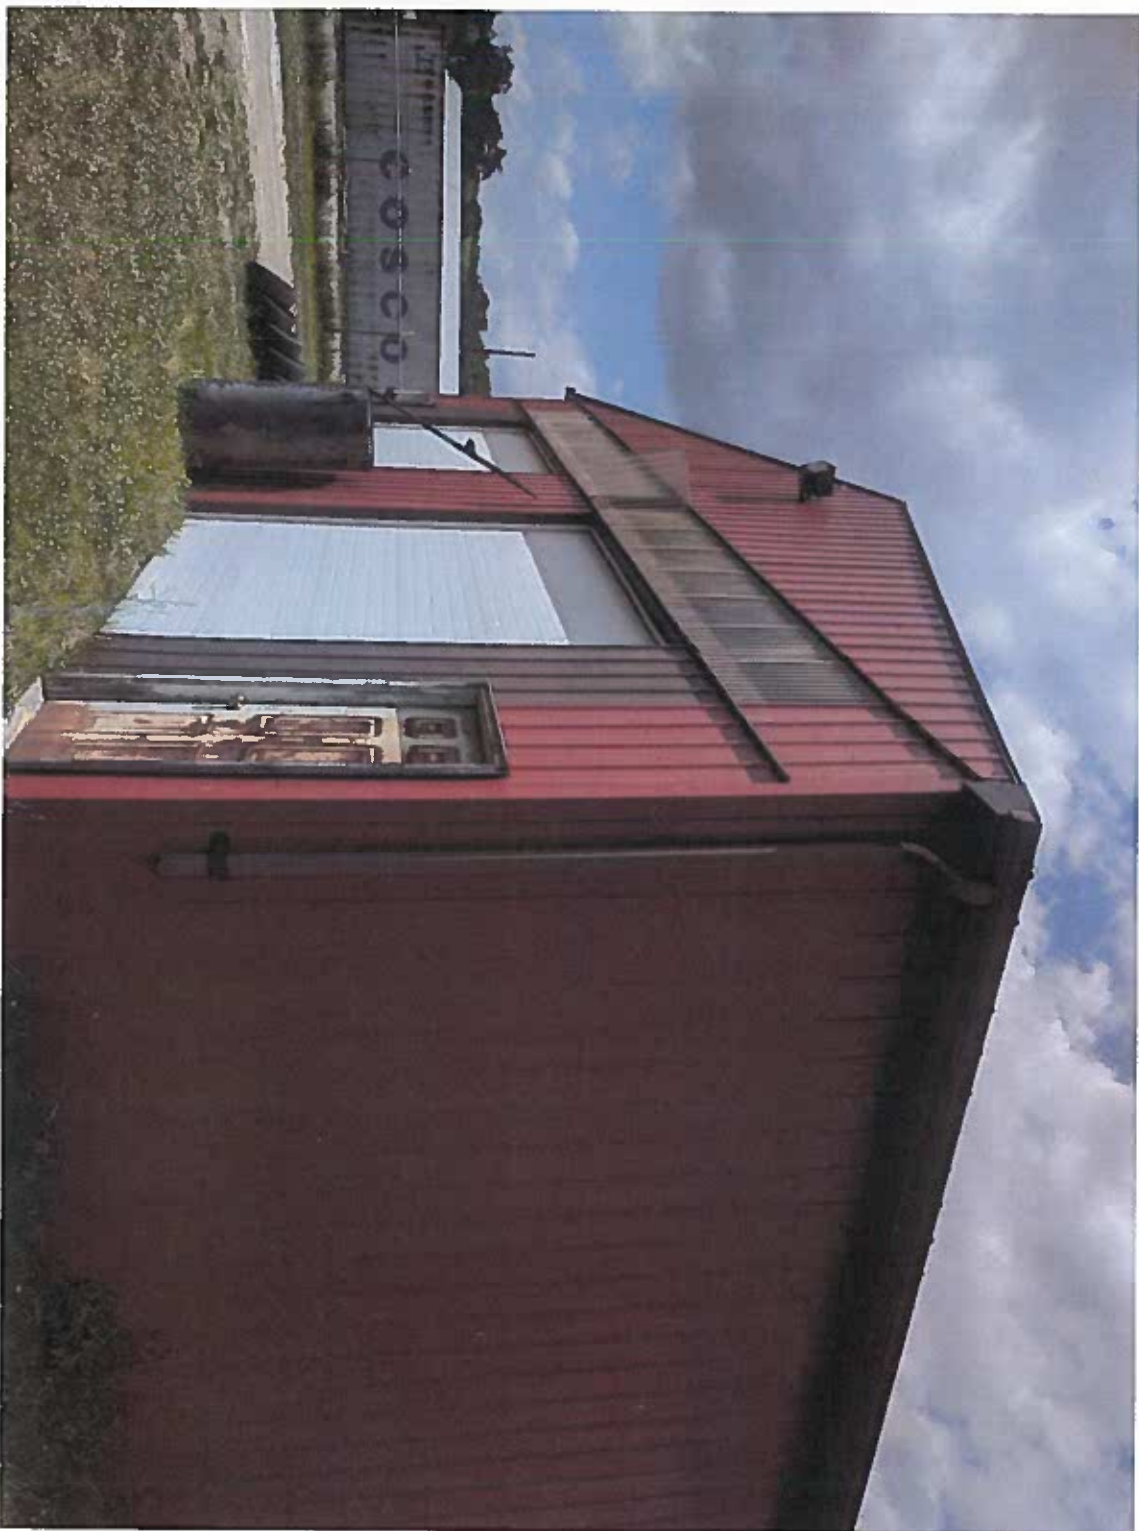
Extremely rusty rear door in need of paint. Grass needs cut. Additional views of trim pulling away above rear garage doors.

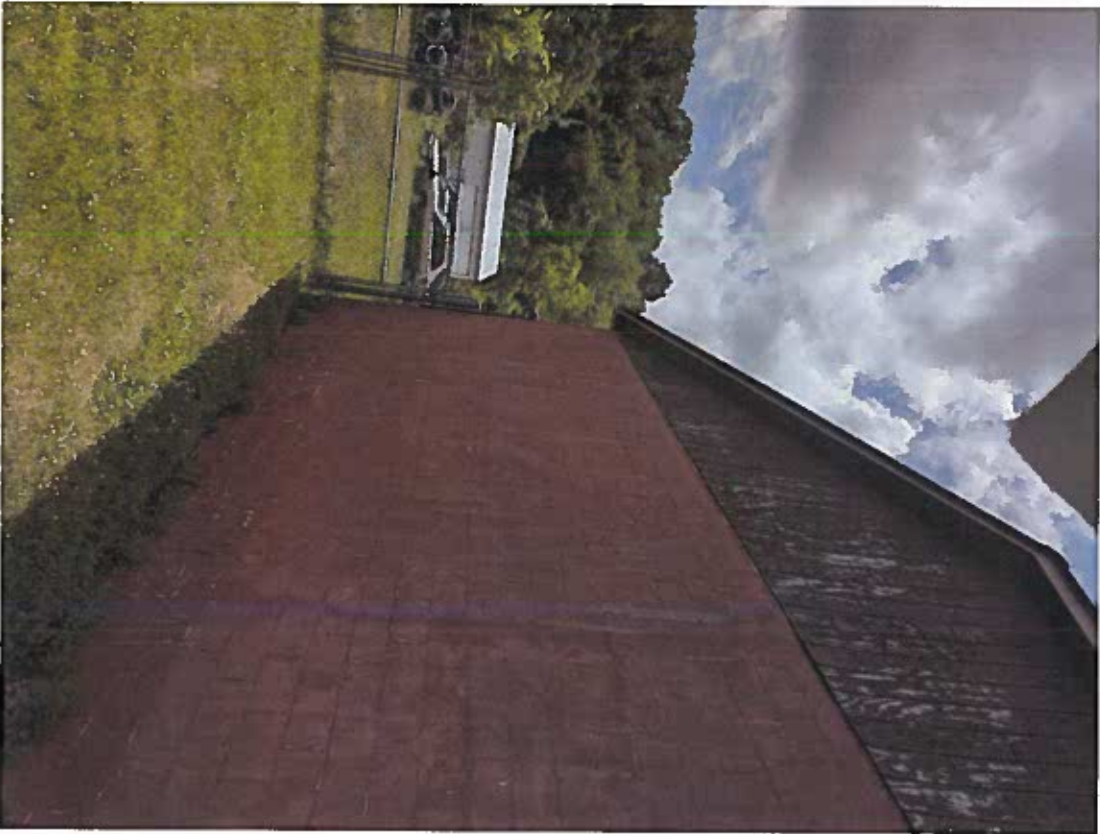
Wooden roof panels are in need of painting.

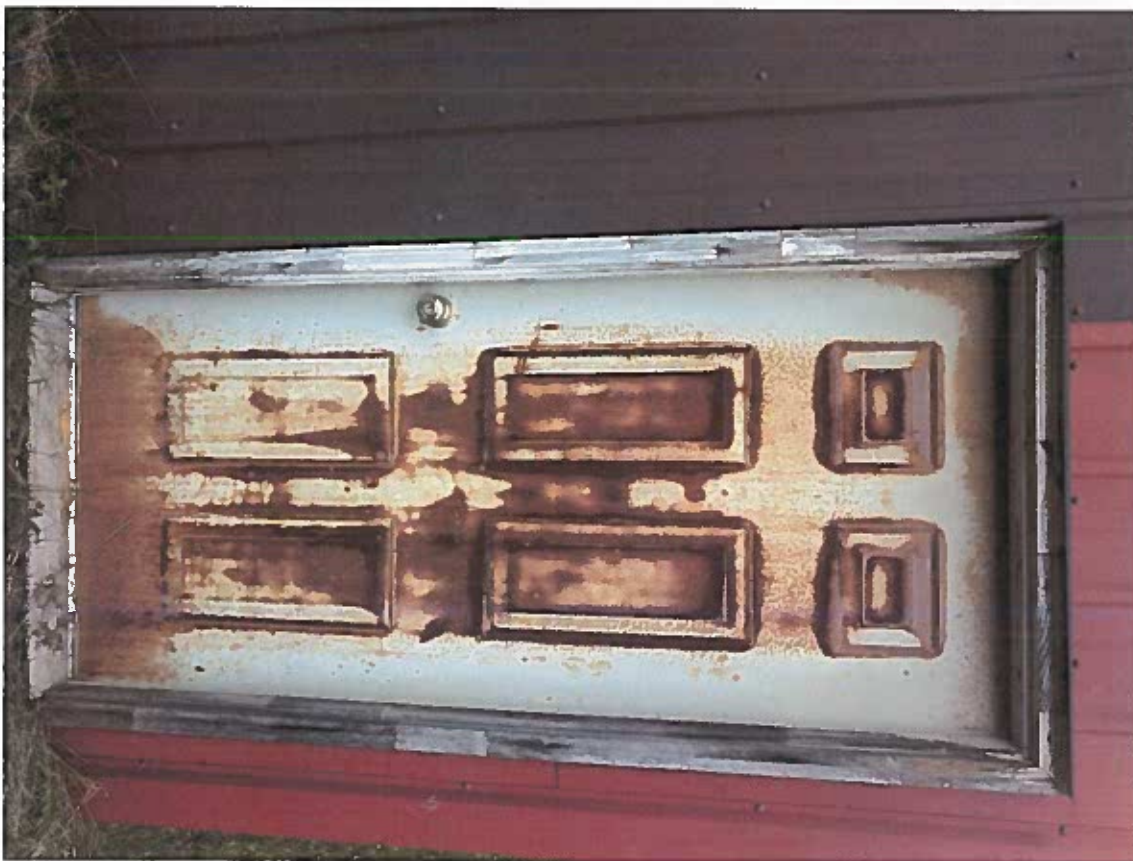
Rusty door. Unpainted trim.

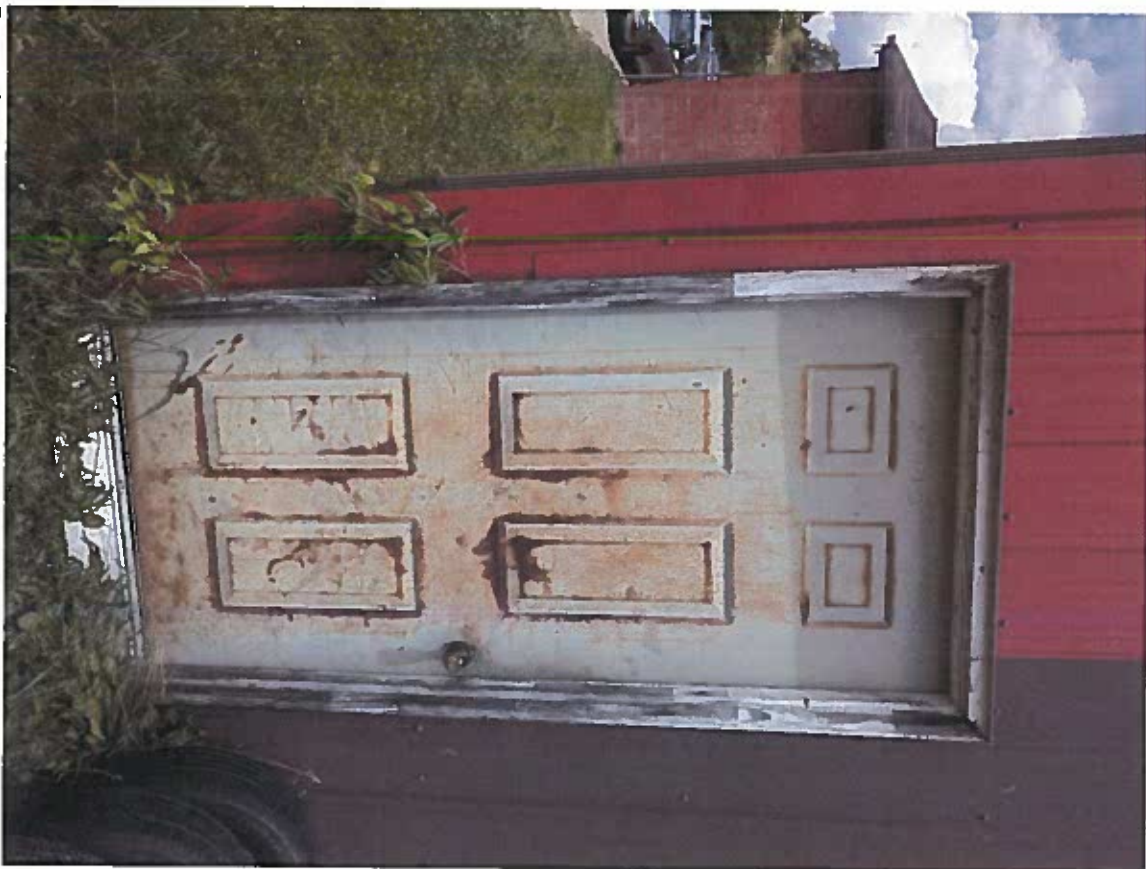
Rusty door, unpainted trim, plants growing under trim.

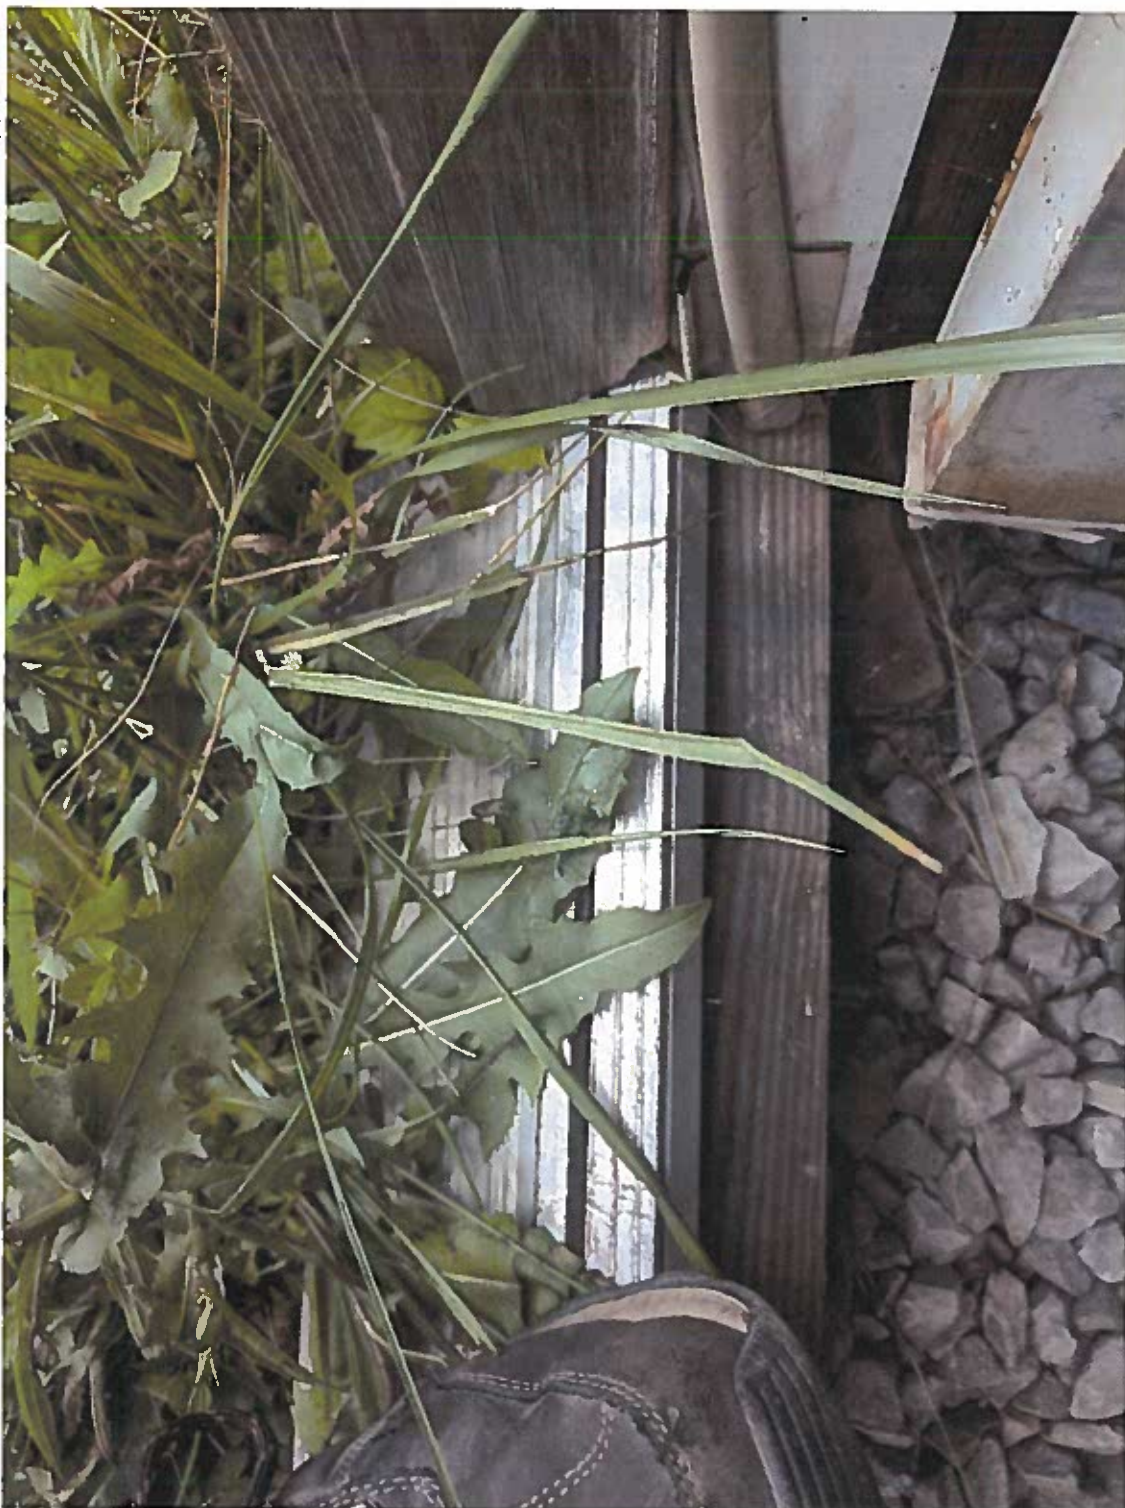
Damaged lower door plate view #1

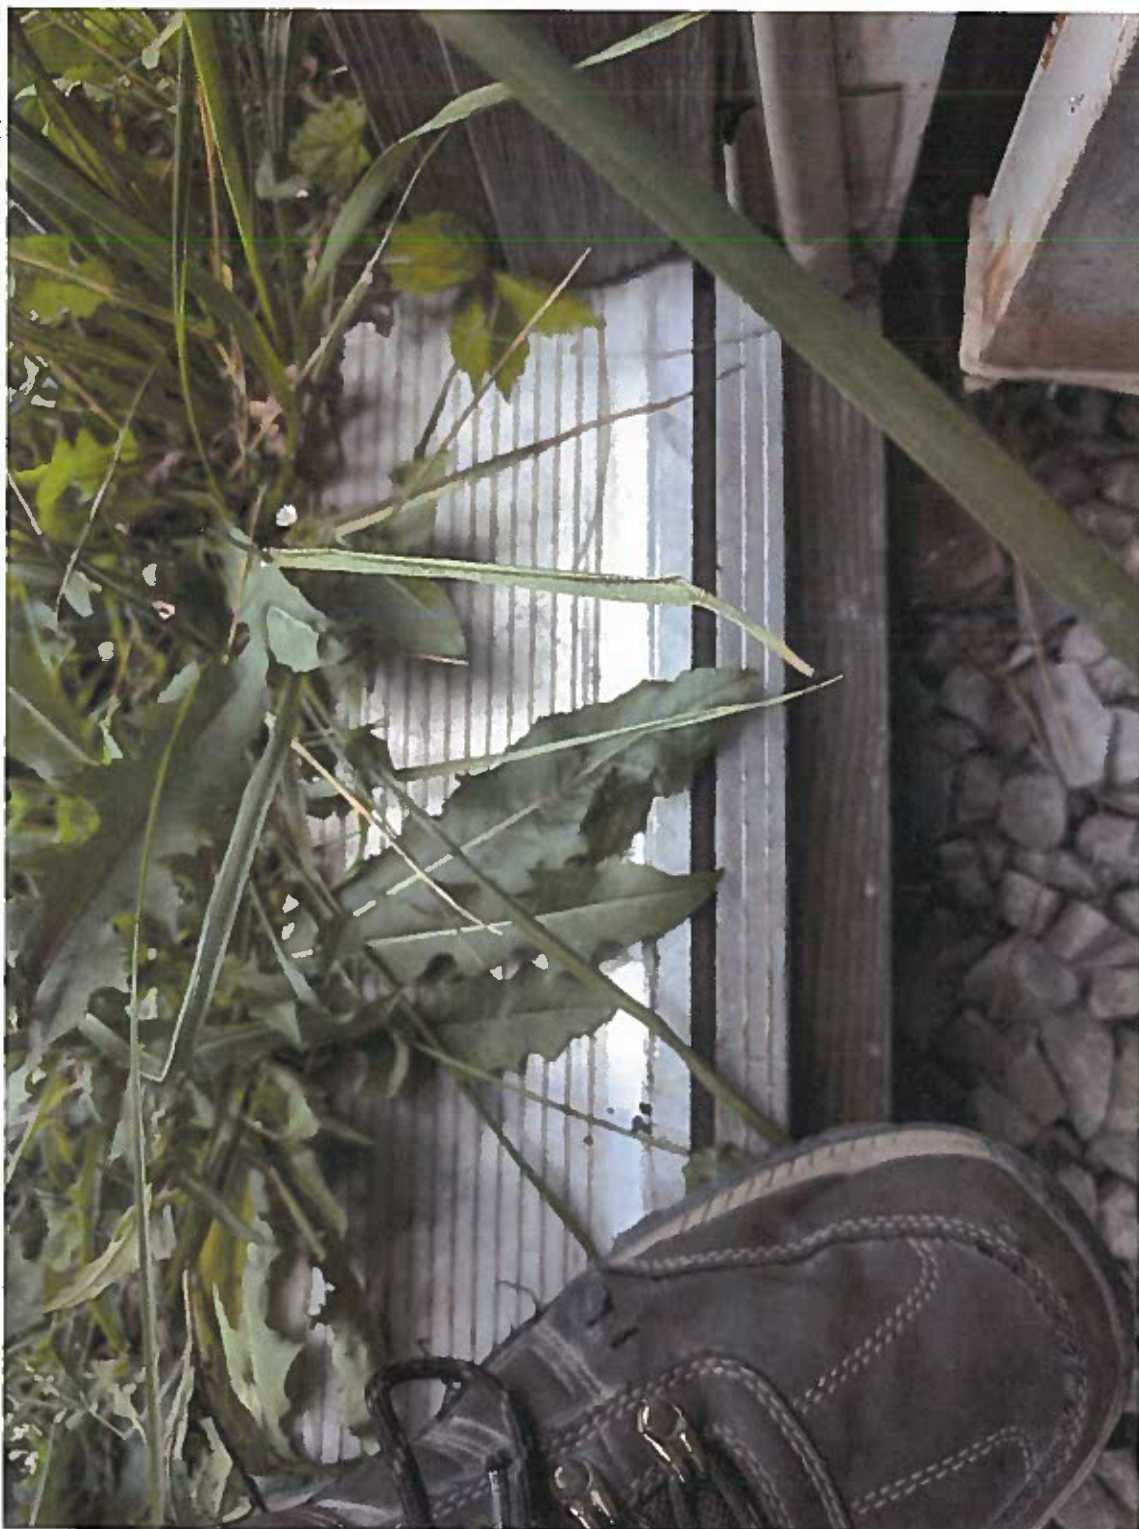
Damaged lower door plate view #2

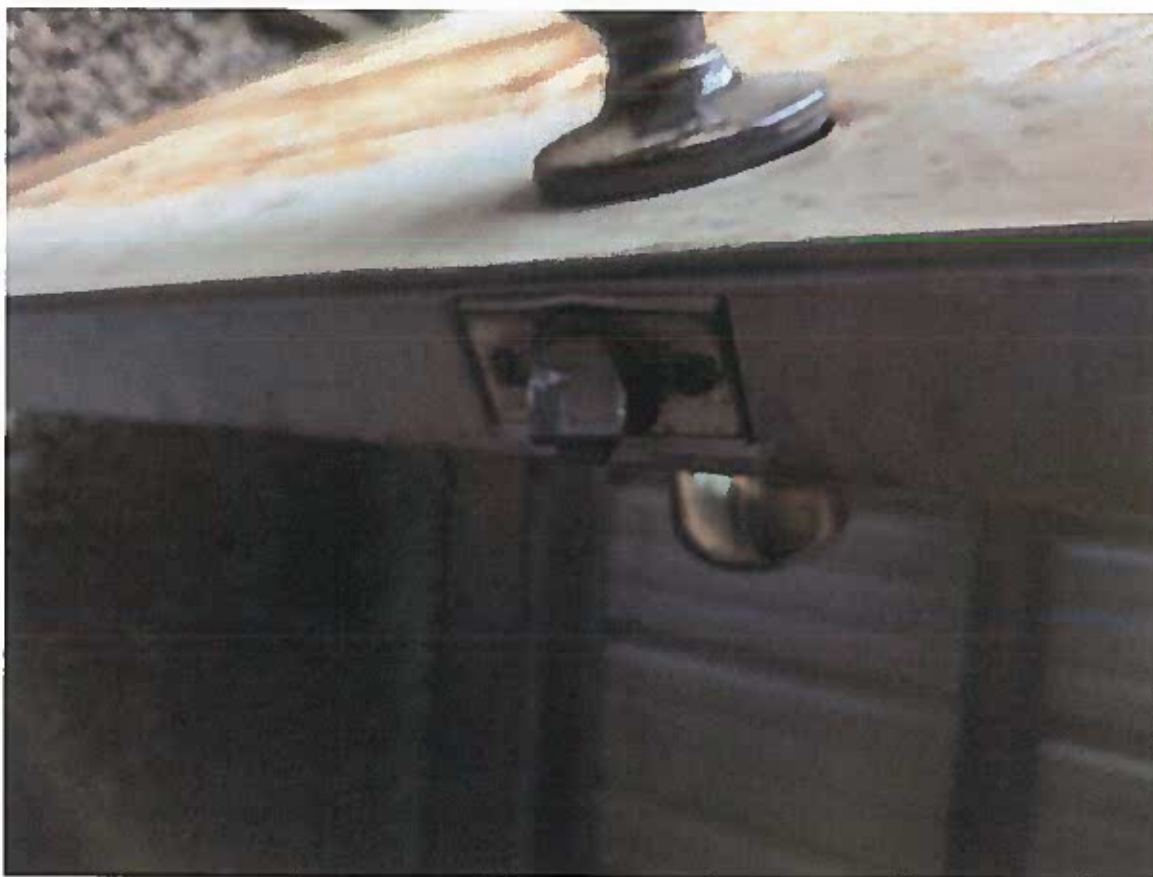
Door striker plate damage

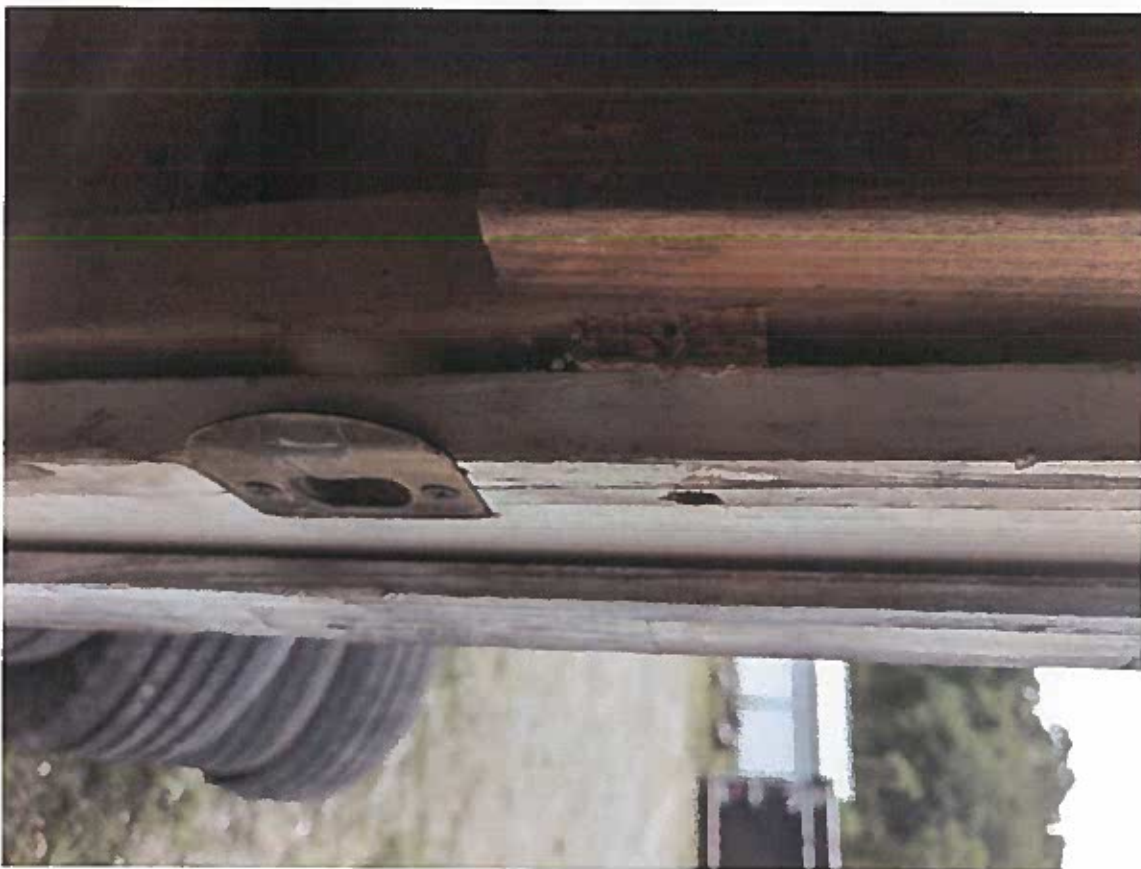
Bent / damaged wood around door frame.

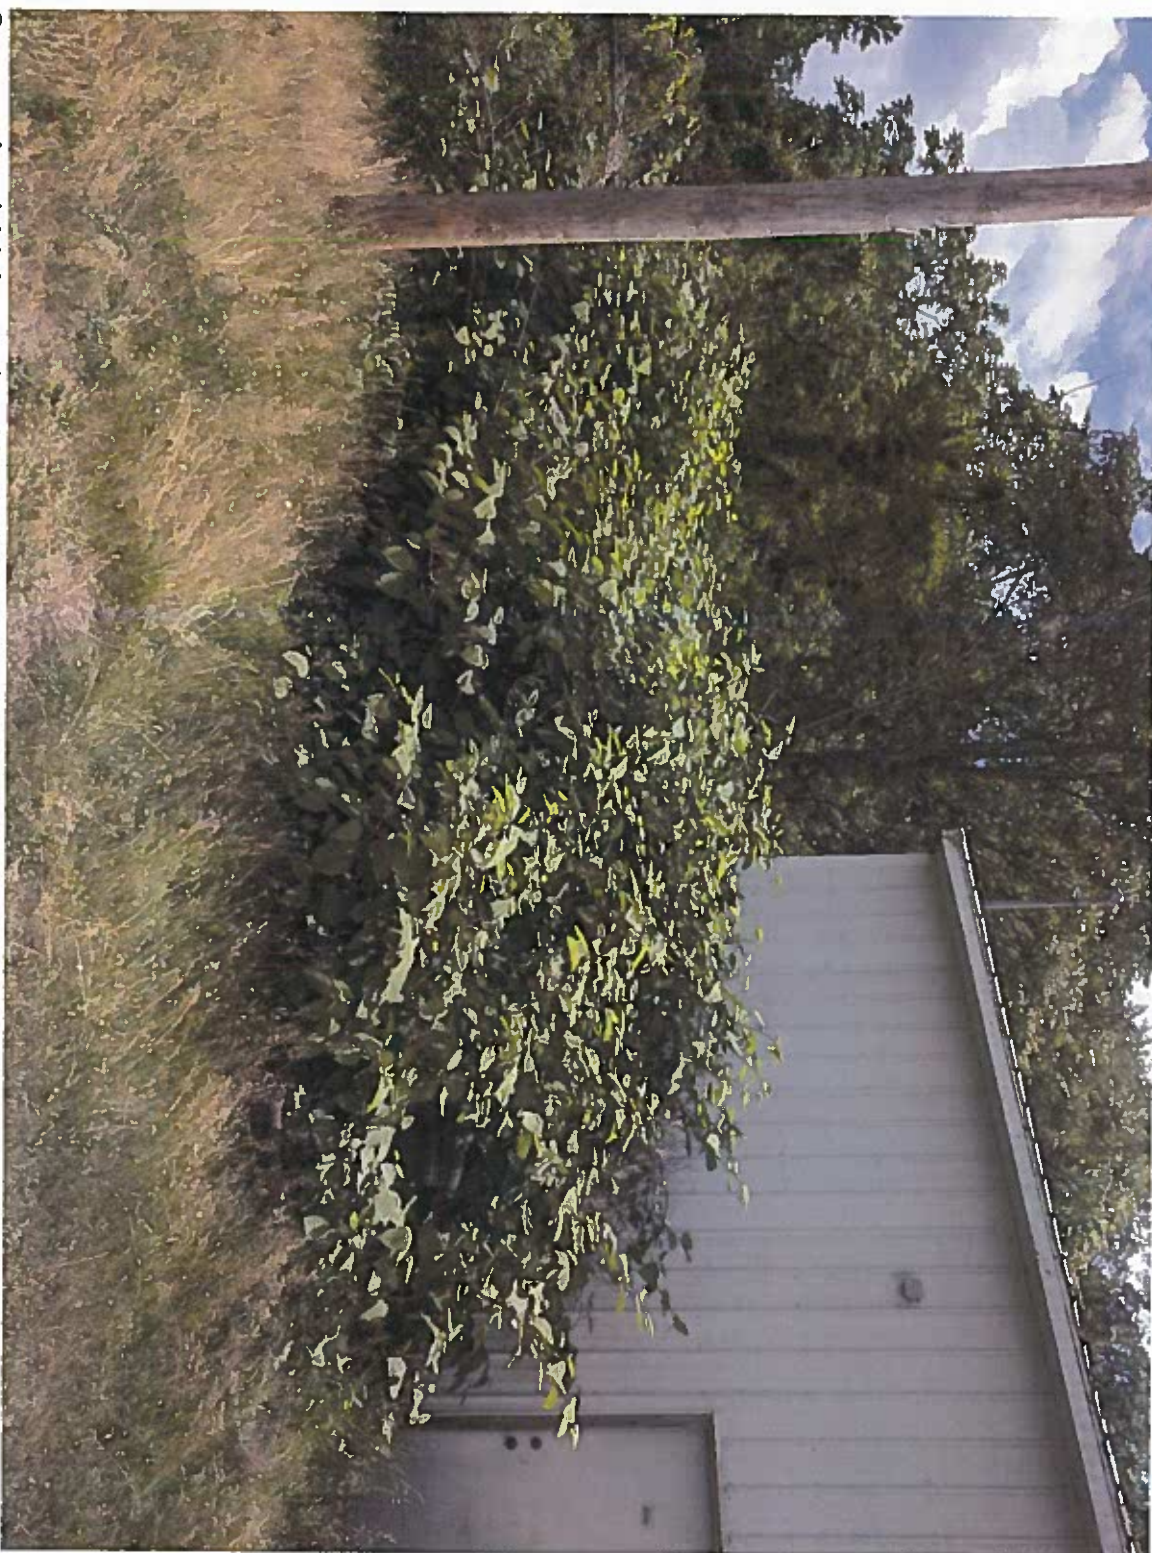
Overgrowth and debris near the white shed on the rear of the property.

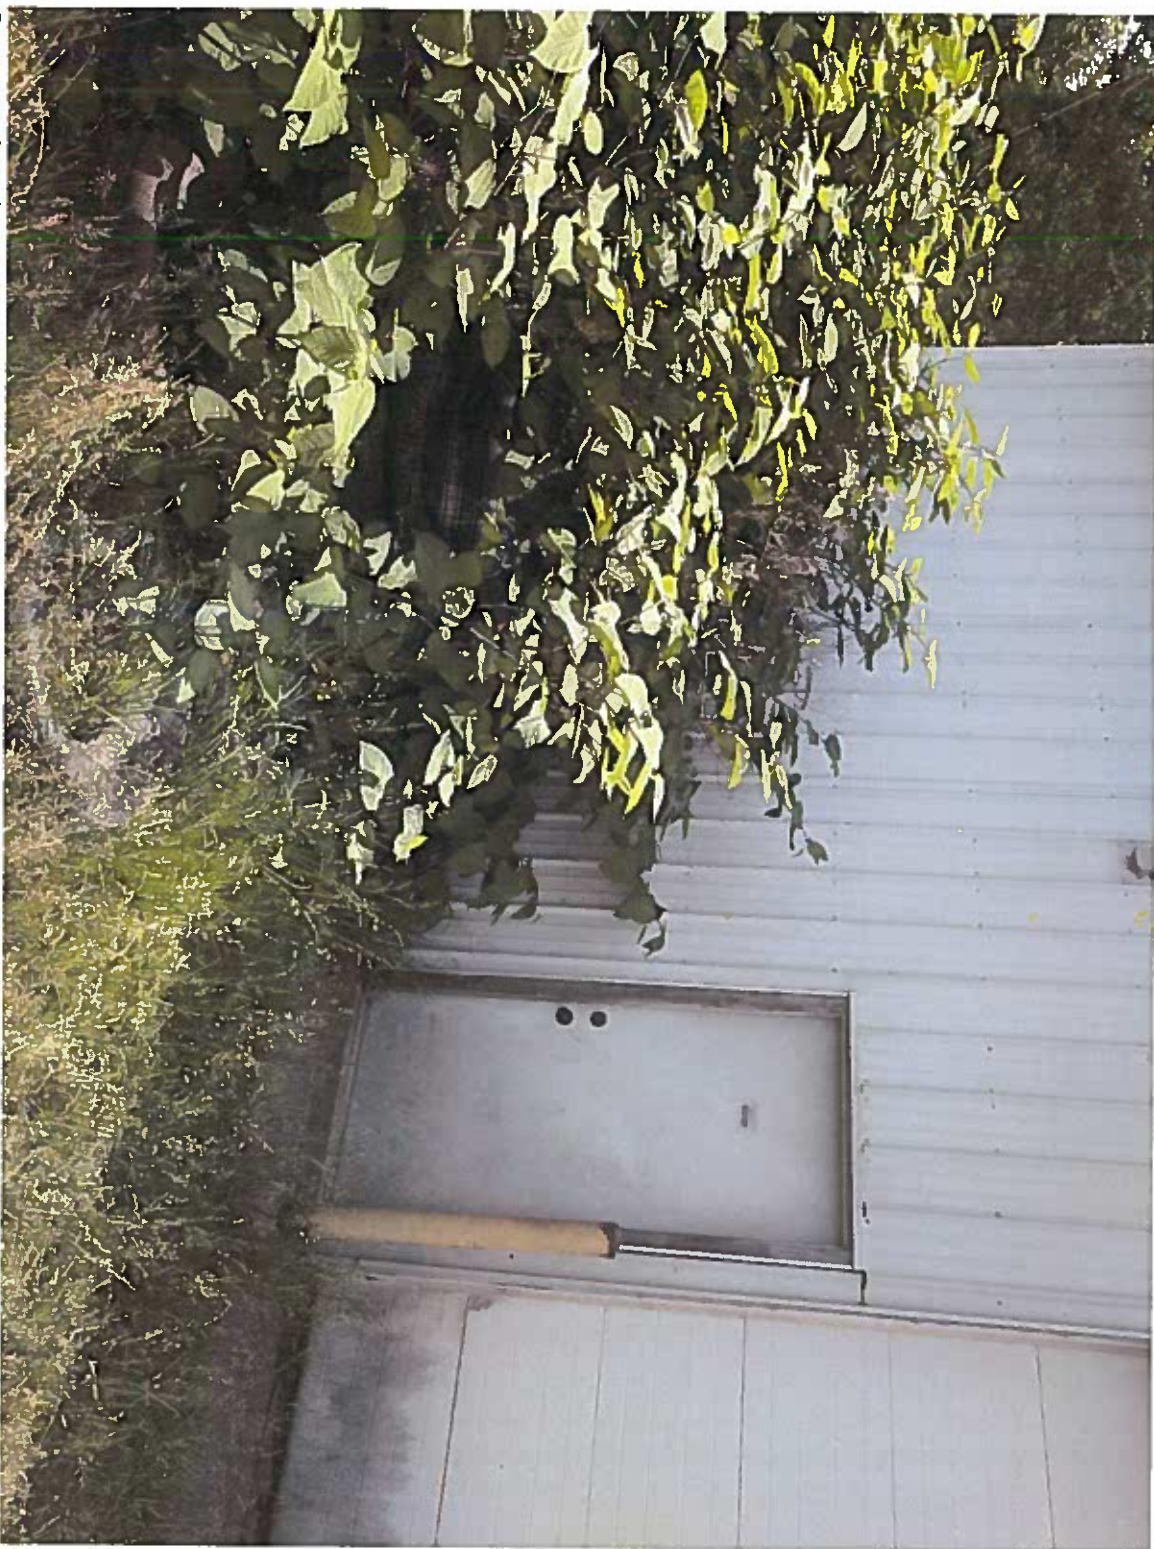
Overgrowth and debris near the white shed on the rear of the property. Notice the rear door condition.

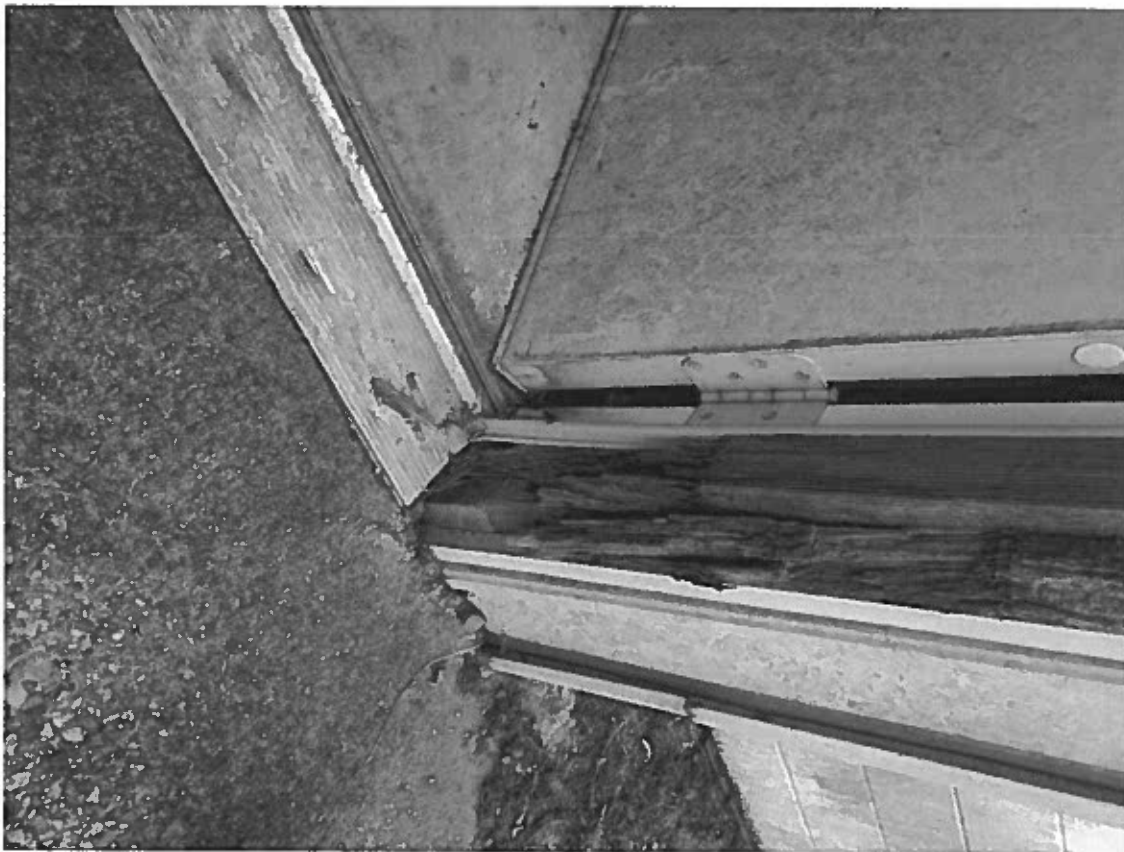
Rotting wood located around rear wooden door.

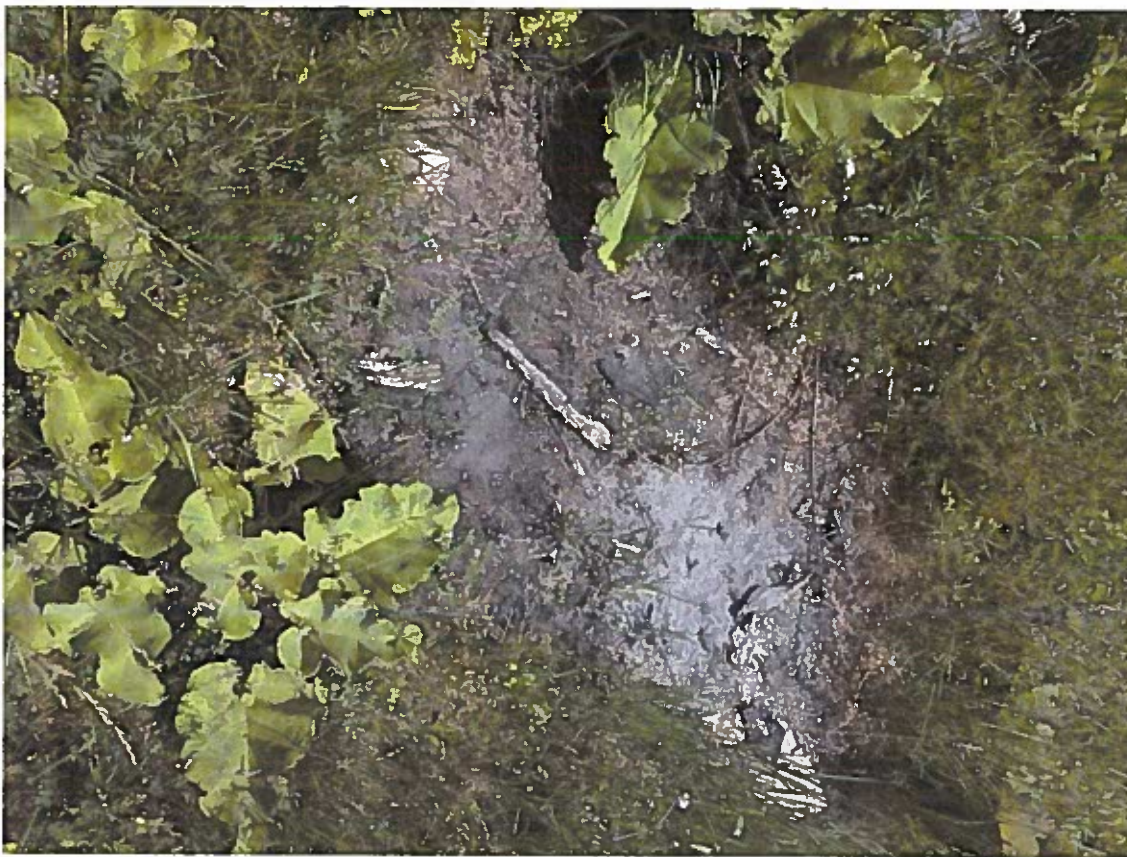
Large burn mark in the ground adjacent to the rear white shed.
